The Road Inventory of Ouray National Wildlife Refuge Randlett, UT

Prepared By: Federal Highway Administration Central Federal Lands Highway Division April 2008

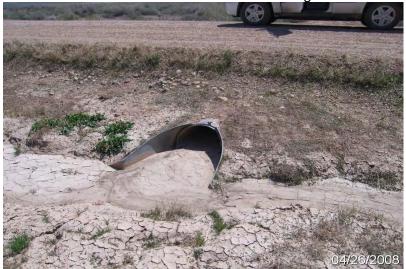
Photo # 4375 - MP 3.72 - Culvert Deficiency

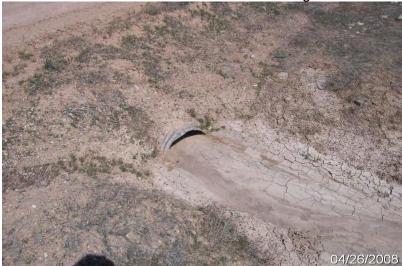
Photo # 4376 - MP 3.72 - Culvert Deficiency

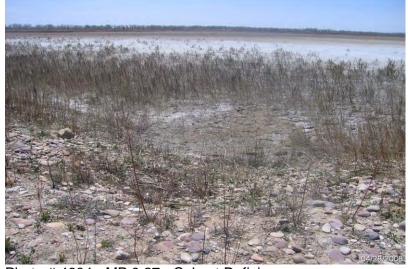
Photo # 4604 - MP 0.27 - Culvert Deficiency

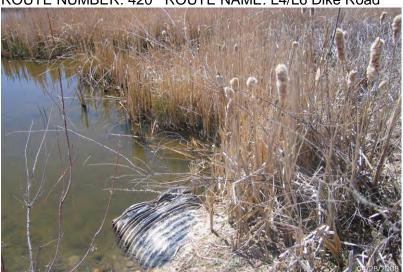
Photo # 4614 - MP 0.32 - Culvert Deficiency

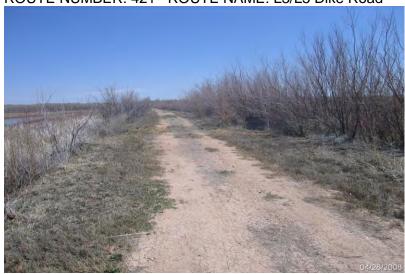
Photo # 4615 - MP 0.32 - Culvert Deficiency

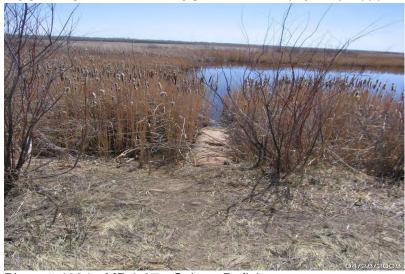
Photo # 4623 - MP 0.27 - Culvert Deficiency

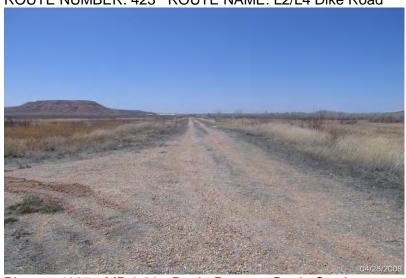
Photo # 4624 - MP 0.27 - Culvert Deficiency

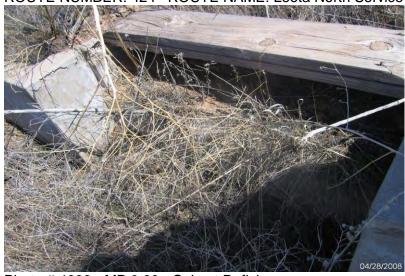
Photo # 4638 - MP 0.60 - Culvert Deficiency

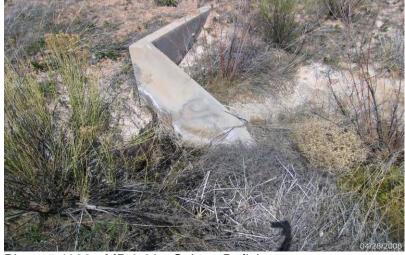
Photo # 4639 - MP 0.60 - Culvert Deficiency
